PEWeldBank PEWeldBank Individual Weld Report

Date	Weld Number	Custom Weld Number	Start Time	Ambient Temp	Status
08-02-2023	2023020811192976	26	11:19	22.1° C	For Review

Project Name	Job Number	Project Contact Details
DK version	Roco værksted	Test 98177977

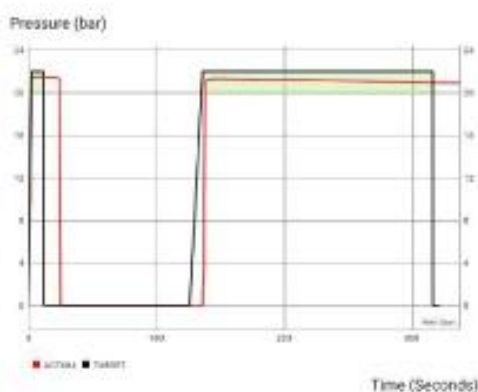
Weld Details	Required	Actual	
P1 bead-up pressure	19.8-22.2	0.9-21.5	bar
t1 bead-up size	Until indication of bead	24.00	mm / Seconds
P2 heat soak pressure	0.0-0.0	0.0-0.0	bar
t2 heat soak time	110	110	Seconds
t3 heater plate removal time	≤4	≤4	Seconds
t4 time to achieve fusion jointing pressure	≤10	≤10	Seconds
P3 fusion jointing pressure	19.8-22.2	20.9-21.3	bar
t5 fusion jointing time (bead roll-over time)	≥03:00	03:00	Min:Sec

** Manual override has been enabled by the user

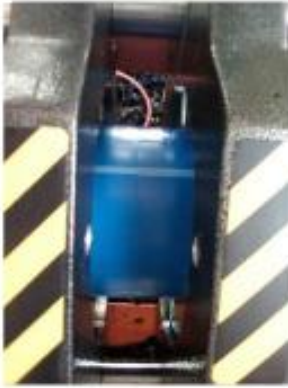
Alignment Photo

Is weld area protected?	Yes
Have the pipes been cleaned before placing in machine?	Yes
Are pipe ends covered?	Yes
Is pipe faced correctly?	Yes
Have pipe faces been cleaned?	Yes
Have pipe ends been checked for gap?	Yes
Is pipe aligned within 10% of wall thickness?	Yes
